Spring 2022 Water Quality Monitoring in the Hunting Creek Watershed

(Final, January 5, 2023)

by Ron Klauda, Bob Estes, and Mary Hoover

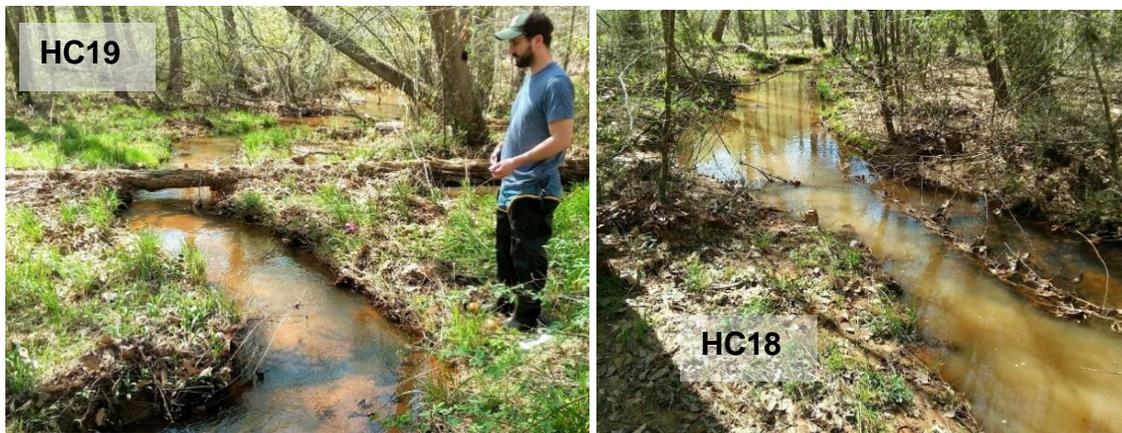
Figure 1 and 2 Macroinvertebrate Test Sites HC19 and HC18

Another activity was added to the FOHC's water quality monitoring program in Spring 2022. At two stream sites (HC19: a tributary to Mill Creek and HC18: Chingaware Run), stream health was evaluated by sampling aquatic benthic macroinvertebrates and also by scoring ten physical habitat parameters. HC19 was sampled on April 9; HC18 on April 16 (Figures 1, 2, 3).

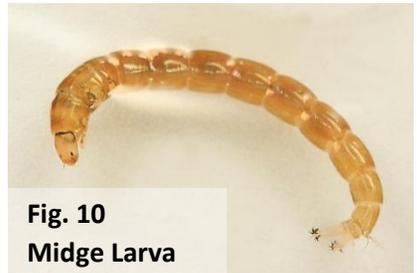
Fig. 10
Midge Larva

Diptera (true flies) taxa were also common at both HC19 (42.1% of all taxa collected) and HC18 (61.5% of all taxa collected). Only those insects having one pair of wings belong to the Diptera. This groups includes flies, mosquitos, gnats, midges, and no-see-ums. There are about 120,000 known species of true flies. The immature life stages (larvae) of many Diptera species (e.g., midges, Figure 10 and craneflies, Figure 11) inhabit freshwater and estuarine habitats.

In general, Diptera taxa have moderate to high tolerance values, meaning they are somewhat tolerant to most tolerant to environmental stressors. However, one Dipteran genus (*Potthastia sp.*), with a tolerance value of 0 (least tolerant, most sensitive) was found in the macroinvertebrate sample collected at HC18. Tolerance values for the eight Diptera taxa collected at HC19 ranged from 4.6 to 9.2 (on the 0 to 10 scale), with average and median tolerance values of 6.6 and 6.5, respectively. Tolerance values for the 16 Diptera taxa collected at HC18 ranged from 0 to 9.2, with average and median tolerance levels of 5.9 and 6.1, respectively.
