Spring 2022 Water Quality Monitoring in the Hunting Creek Watershed

(Final, January 5, 2023)

by Ron Klauda, Bob Estes, and Mary Hoover

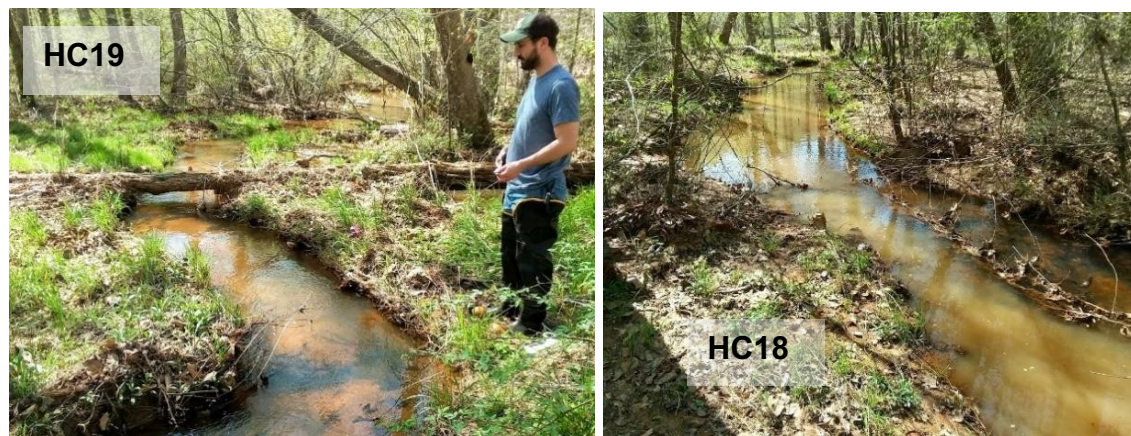
Figure 1 and 2 Macroinvertebrate Test Sites HC19 and HC18

Another activity was added to the FOHC's water quality monitoring program in Spring 2022. At two stream sites (HC19: a tributary to Mill Creek and HC18: Chingaware Run), stream health was evaluated by sampling aquatic benthic macroinvertebrates and also by scoring ten physical habitat parameters. HC19 was sampled on April 9; HC18 on April 16 (Figures 1, 2, 3).

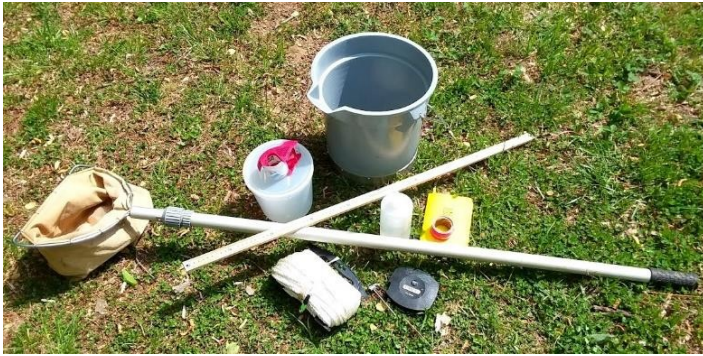
Figure 3 Macroinvertebrate Sampling Equipment

Macroinvertebrates were collected using Maryland Biological Stream Survey (MBSS) methods (Ref 2) and identified by Istvan Turcsanyi (a certified macroinvertebrate taxonomist) to family and genus level.

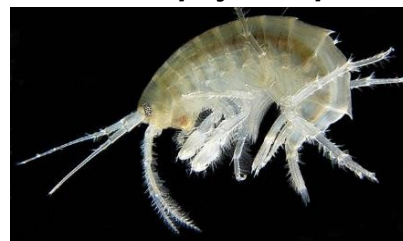
Fig. 9
Cheumatopsyche sp.

Gammarus sp. (Figure 9), a somewhat pollution-tolerant amphipod crustacean (tolerance value = 6.7 on a 0 to 10 scale, from least to most tolerant) were the most common taxa collected at both sites: 41.4% of all macroinvertebrates at HC19 and 30.9% at HC18. *Gammarus sp.*

comprise a diverse group of freshwater shrimps that includes more than 200 species worldwide. They often represent the dominant macroinvertebrate species, by weight, in freshwater streams. *Gammarus sp.* also represent important keystone aquatic species because they play a central role in the detritus cycle (e.g., litter breakdown processes). They also constitute an important component in aquatic food webs by being food items for fish. Four or five species of *Gammarus* inhabit Maryland waters, but they are challenging to distinguish.

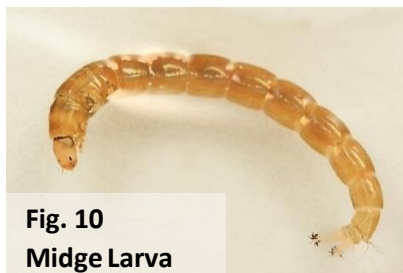
Fig. 10
Midge Larva

Diptera (true flies) taxa were also common at both HC19 (42.1% of all taxa collected) and HC18 (61.5% of all taxa collected). Only those insects having one pair of wings belong to the Diptera. This group includes flies, mosquitos, gnats, midges, and no-see-ums. There are about 120,000 known species of true flies. The immature life stages (larvae) of many Diptera species (e.g., midges, Figure 10 and craneflies, Figure 11) inhabit freshwater and estuarine habitats.

In general, Diptera taxa have moderate to high tolerance values, meaning they are somewhat tolerant to most tolerant to environmental stressors. However, one Dipteran genus (*Potthastia sp.*), with a tolerance value of 0 (least tolerant, most sensitive) was found in the macroinvertebrate sample collected at HC18. Tolerance values for the eight Diptera taxa collected at HC19 ranged from 4.6 to 9.2 (on the 0 to 10 scale), with average and median tolerance values of 6.6 and 6.5, respectively. Tolerance values for the 16 Diptera taxa collected at HC18 ranged from 0 to 9.2, with average and median tolerance levels of 5.9 and 6.1, respectively.
