**SPRING 2023  
WATER QUALITY  
MONITORING IN  
HUNTING CREEK**

**By Ron Klauda, Bob Estes,  
and Mary Hoover**

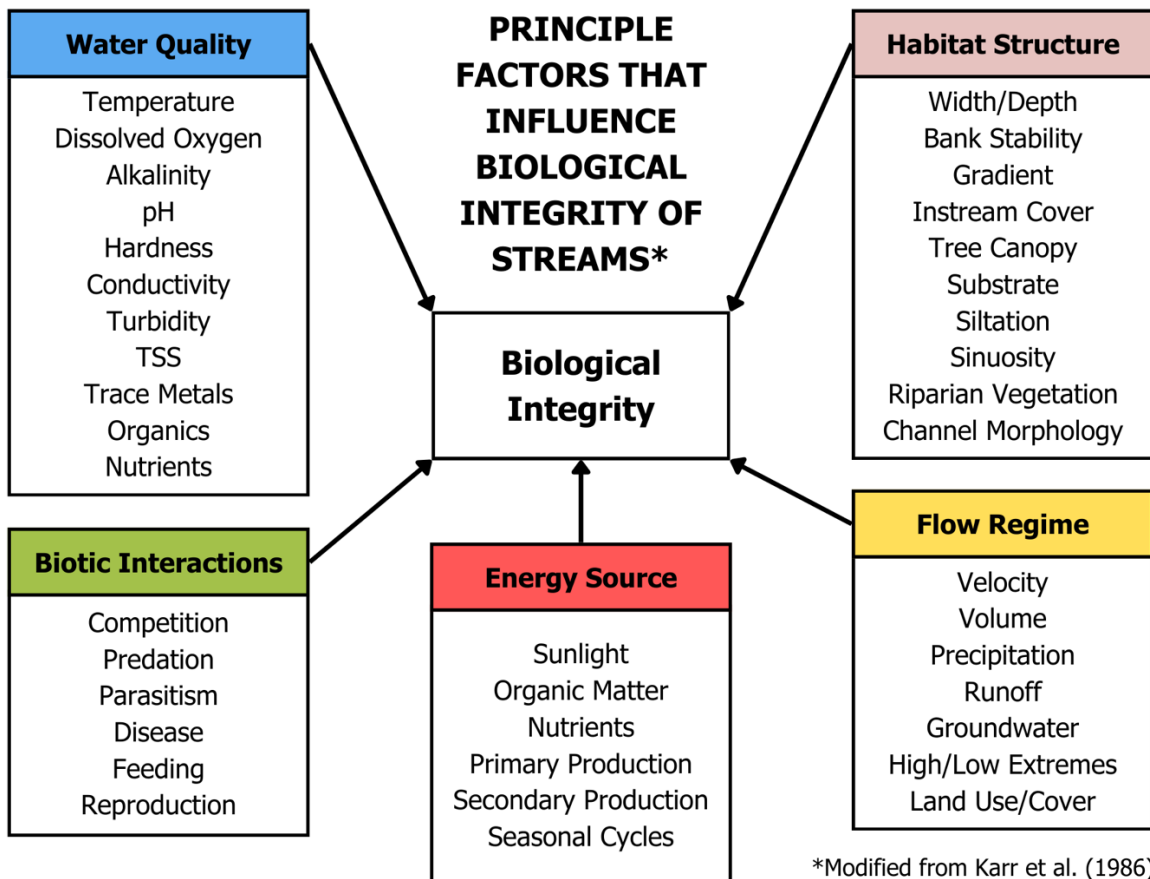
**Figure 3.2**

BIBI scores calculated from macros data are useful for distinguishing degraded from healthy streams. The integrity of macros communities (and other aquatic biota) is influenced by many factors (Figure 3.2). Therefore, identifying the specific stressors that are impacting macros in degraded streams is challenging.

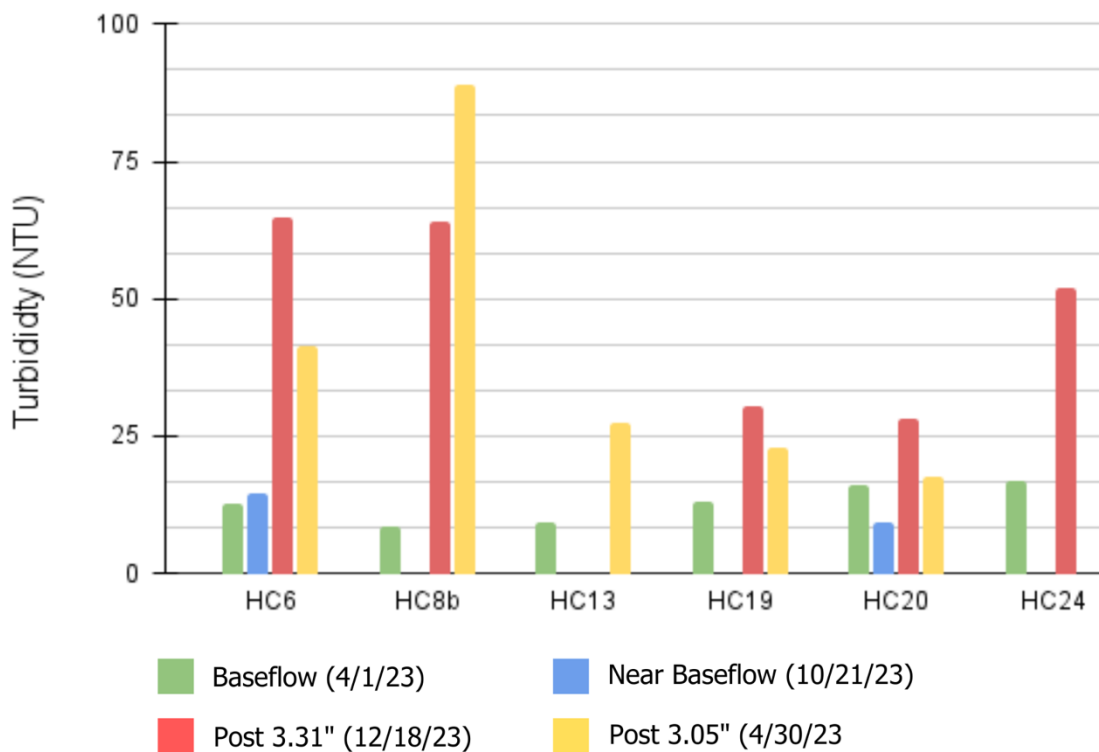
**Figure 4.5**

FOHC volunteers also measured turbidity at six sites in the Hunting Creek watershed immediately after above average rainfall events in 2023: 3.05 in. on 4/1/23 and 3.31 in. on 12/18/23. As shown in Figure 4.5, stream turbidity increased by a factor of only 1 at HC20, compared to baseflow levels, but by a factor of 10.5 (to 88.9 NTUs) at HC8b. Turbidity levels in the 50 to almost 90 NTUs range that persist for more than a day or two would almost certainly be detrimental to aquatic organisms exposed to these conditions.

### **Stream Turbidities at Baseflow and After Rain Events, Hunting Creek Watershed, 2023**

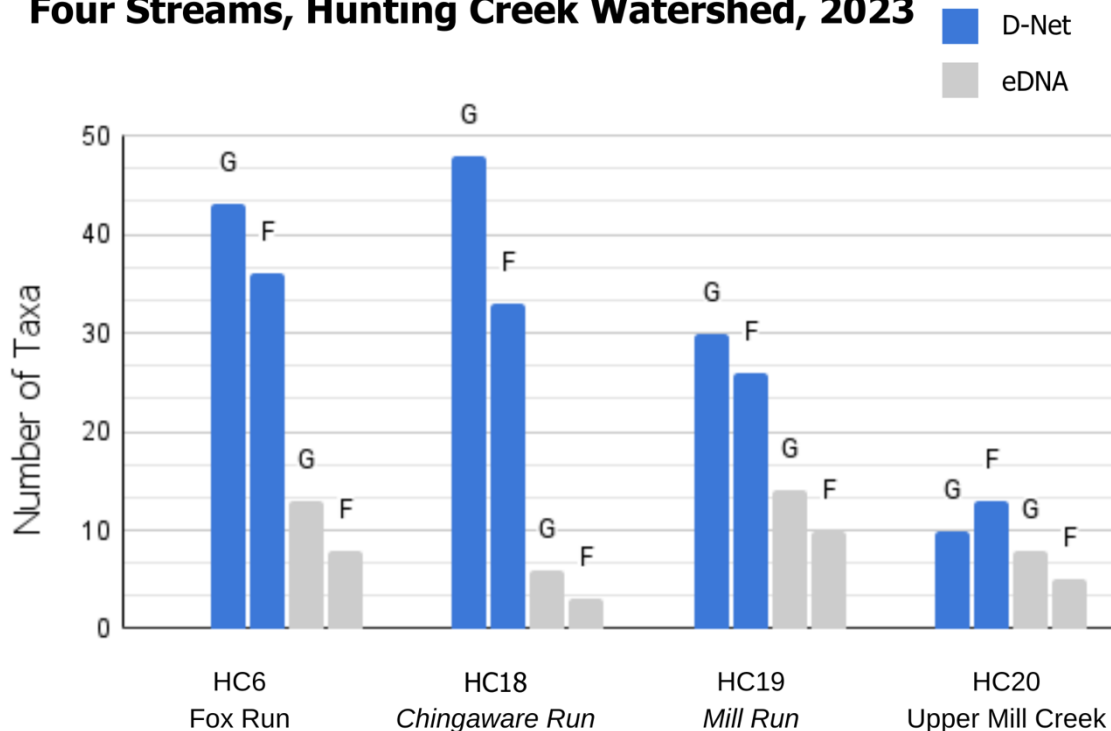
2. Jonah Ventures found macros DNA in water samples collected at the four stream sites (see Tables 1-4 in Appendix E), but the number of macros taxa (families and genera) revealed by eDNA analysis was lower than the taxa numbers collected by FOHC on the same day at the same four sites with a D-net (Figure 4.7). The largest differences in macros diversity revealed by the two sampling methods occurred at HC6, HC18, and HC19. Among the four Pilot Study sites, there were more macros taxa unique to each sampling method than similar (Figure 4.8). Only Six families and two genera of macros were found in both D-net and eDNA samples (Table 4.3), so not much taxa overlap.

### Number of Benthic Macroinvertebrate Families (F) and Genera (G) Collected by D-net versus eDNA Sampling in Four Streams, Hunting Creek Watershed, 2023

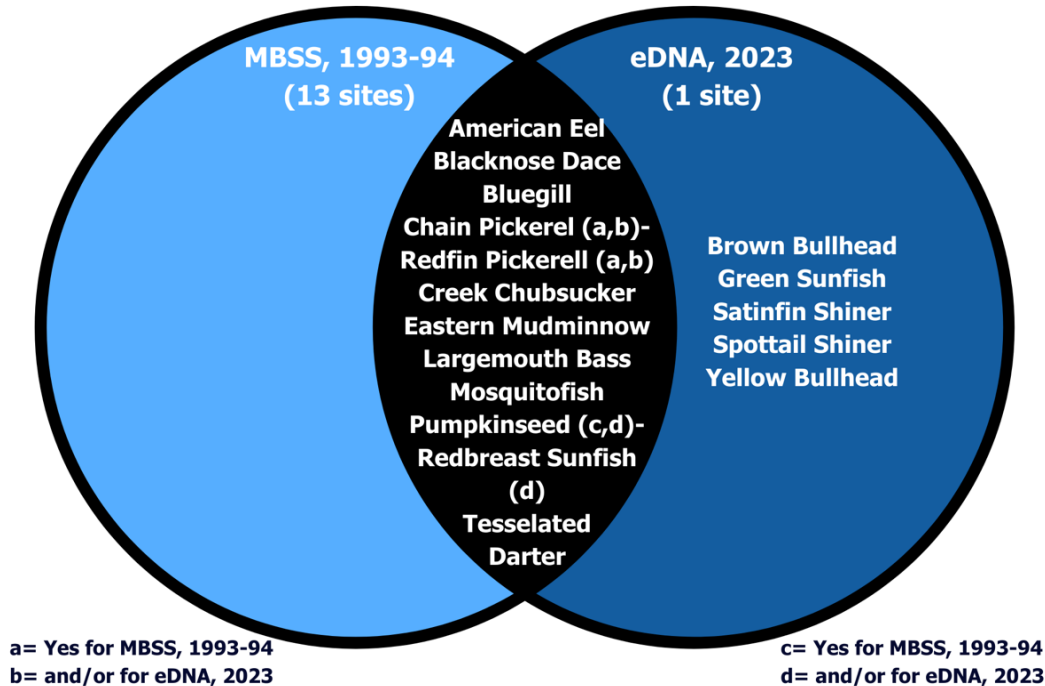
**Figure 4.11**

**Fish Species Found in Fox Run and East Fox Run  
Hunting Creek Watershed**

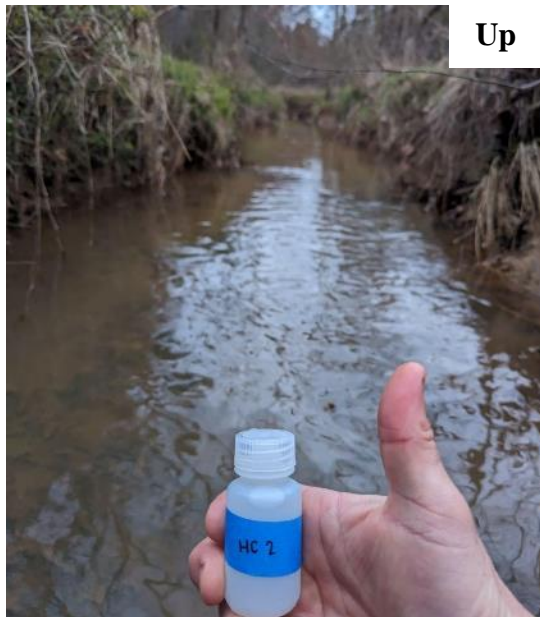
**HC2**

**Mill Creek at Stoakley Rd. bridge, 38.550865, -76.630076**

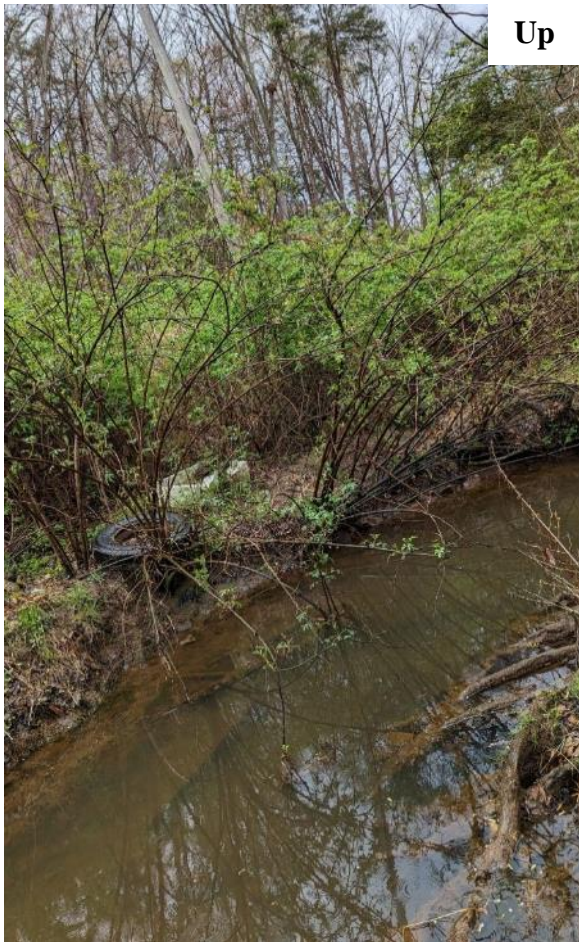
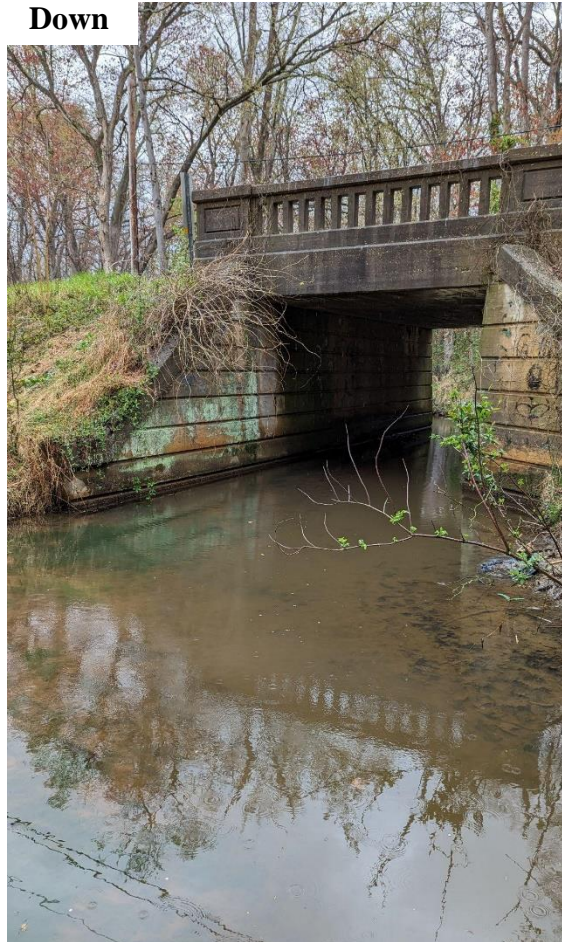
**HC3**

**Little Lyons Creek at Hunting Creek Rd. bridge, 38.573407, -76.656031**

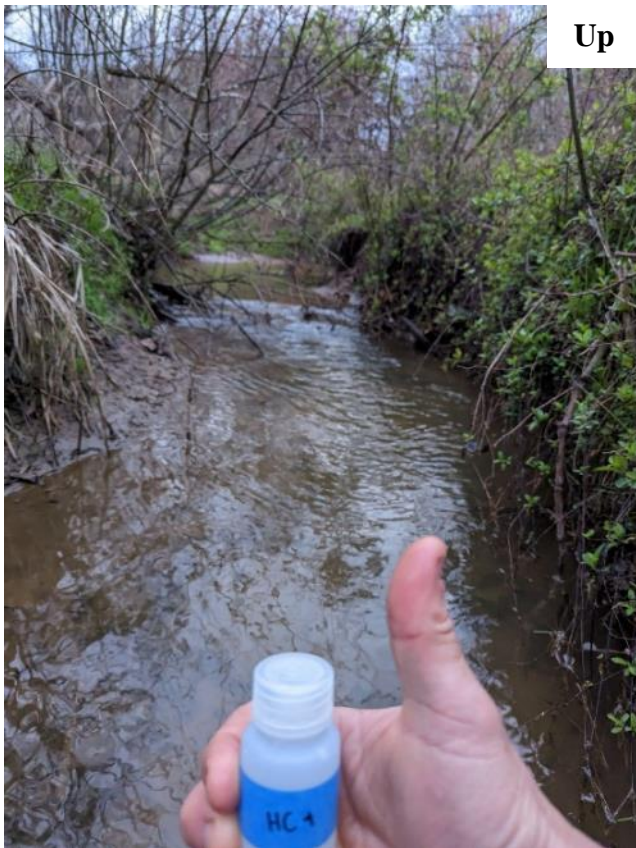
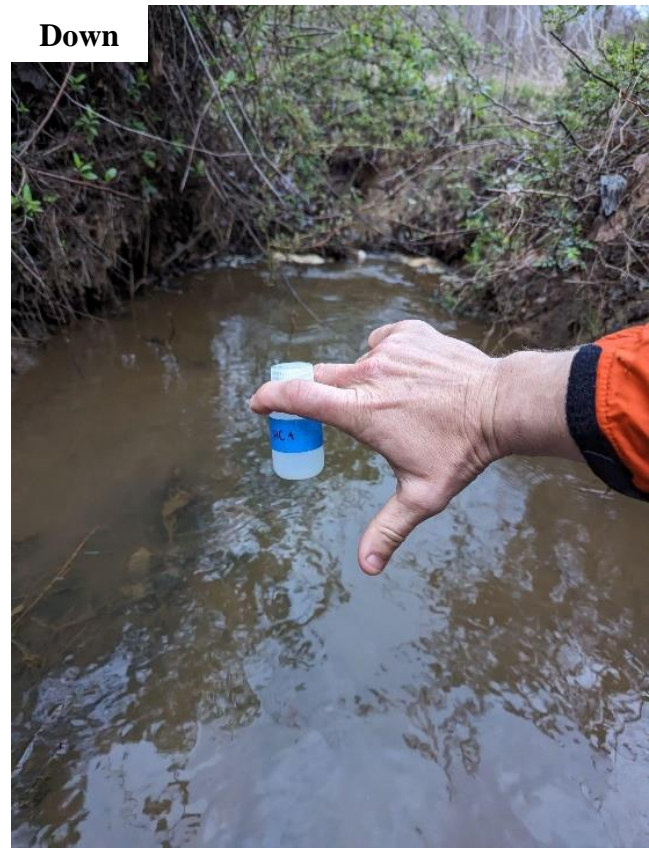
**HC4**

**College Creek, Unnamed Tributary (UT) to Mill Creek, just upstream from Stoakley Rd. bridge, 38.550589, -76.630649**

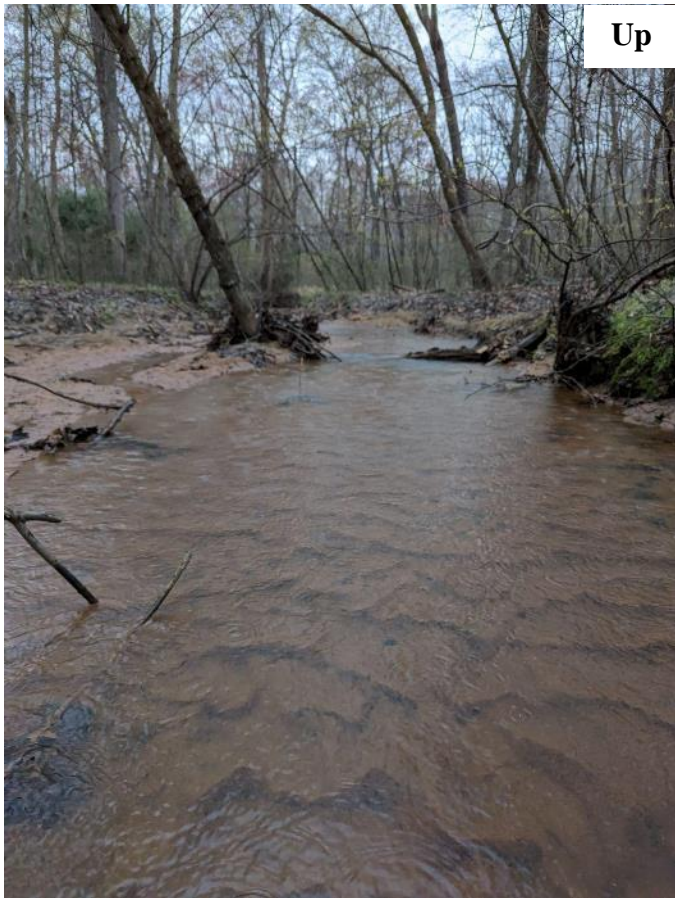
**HC5**

**Mill Creek, Behind 1440 Foxtail Lane, Hunters Ridge, 38.548495, -76.618217**

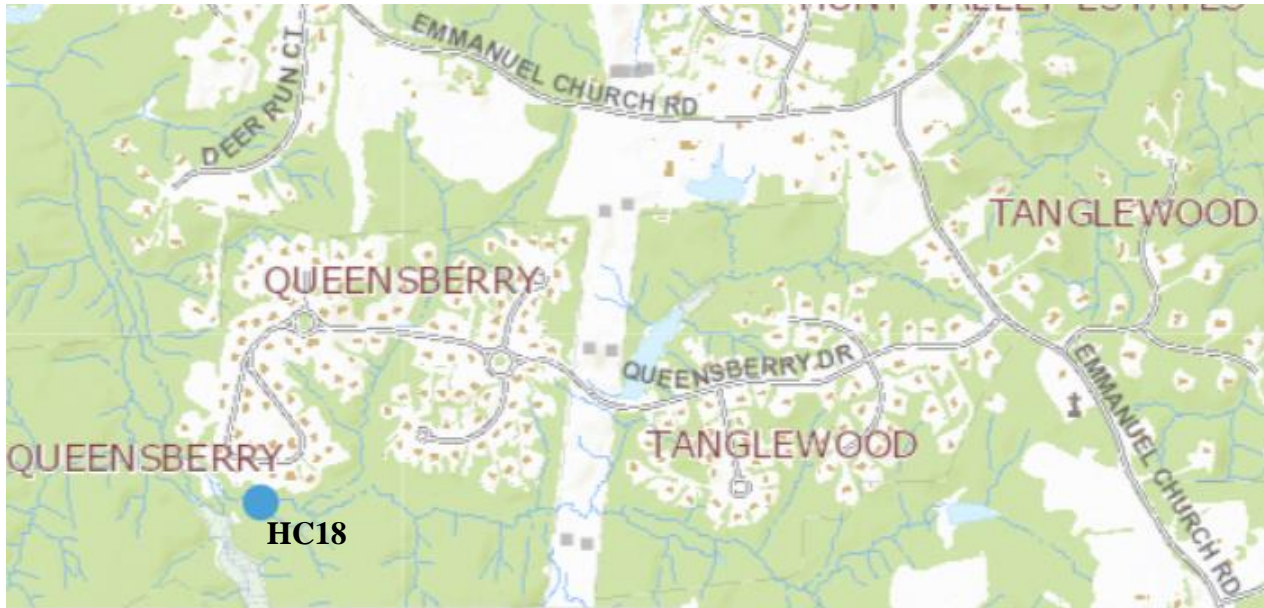
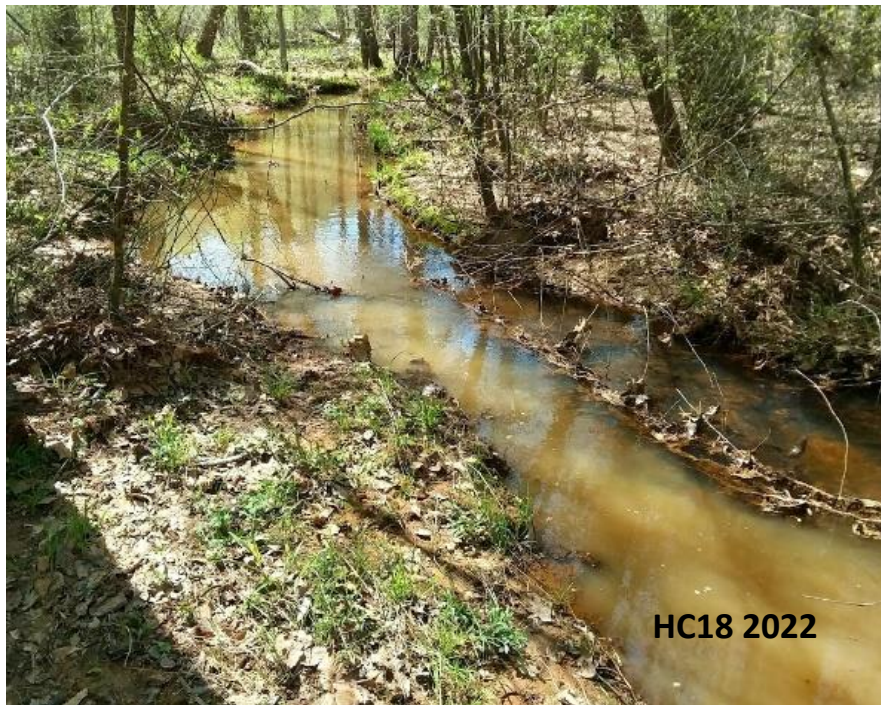
HC18 Macroinvertebrates and eDNA only

UT *Chingaware Run*, Queensberry, 38.581099, -76.560572 (Sample taken over a 75-m long segment of stream, coordinates roughly in middle of span)

Picture was taken approximately midway along the 75m run.

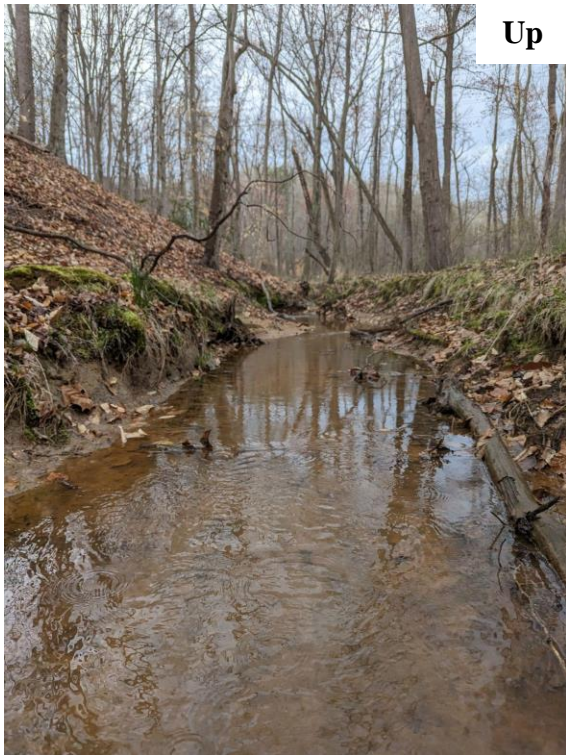
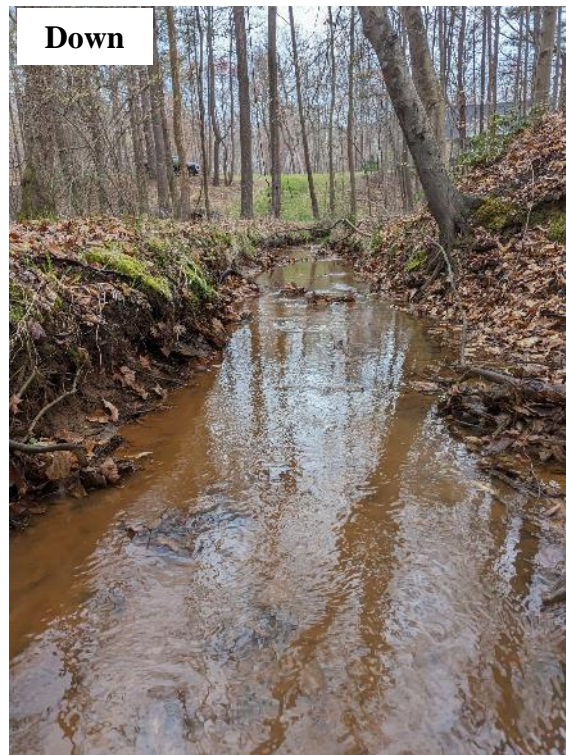
**HC19**

**Willow Run, UT to Willow Way, Hunters Ridge, 38.548962, -76.610882 (Takes the place of HC11 for future sampling)**

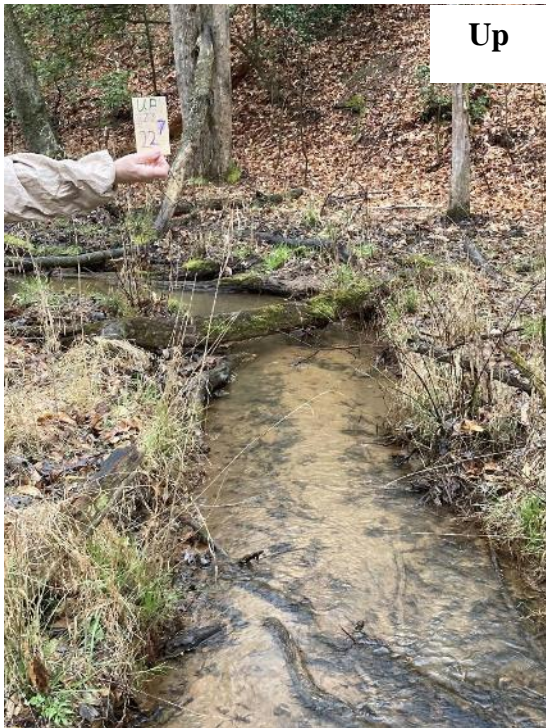
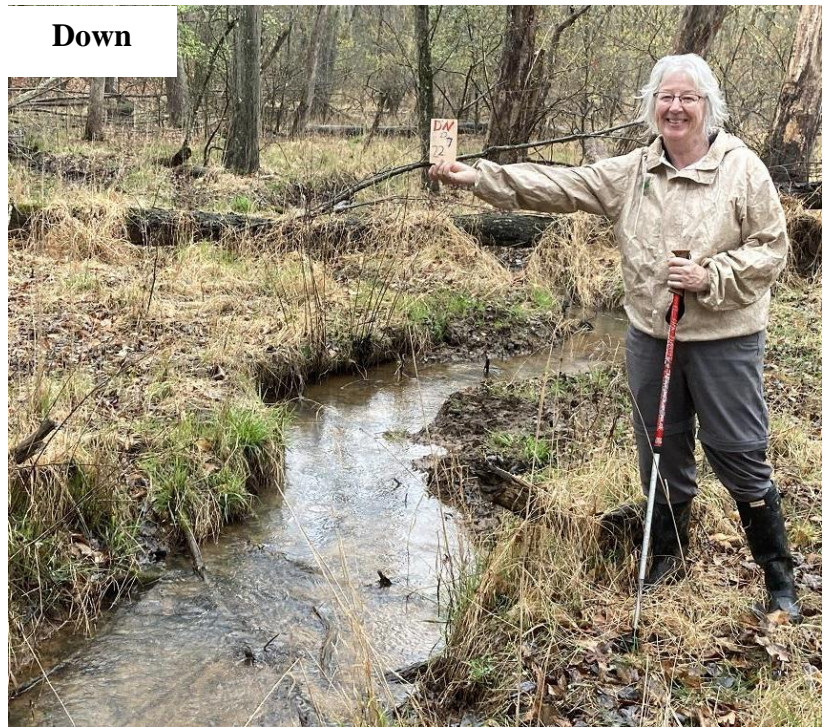
**HC22**

**Winterberry Creek, UT, 38.57751, -76.61970 (avg of picture coordinates)**

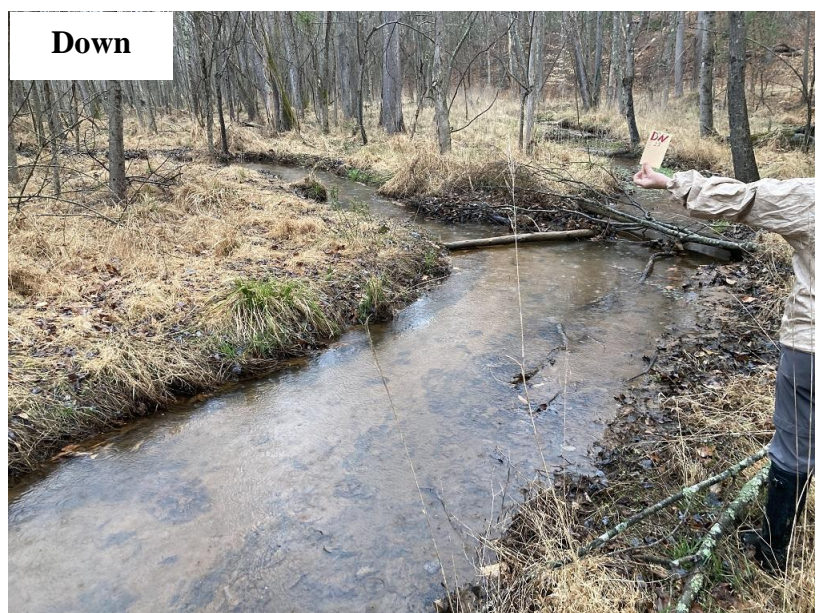
**HC23**

**East Fox Run, Hughes Tree Farm, 38.56750, -76.58208 (avg of pic coordinates)**

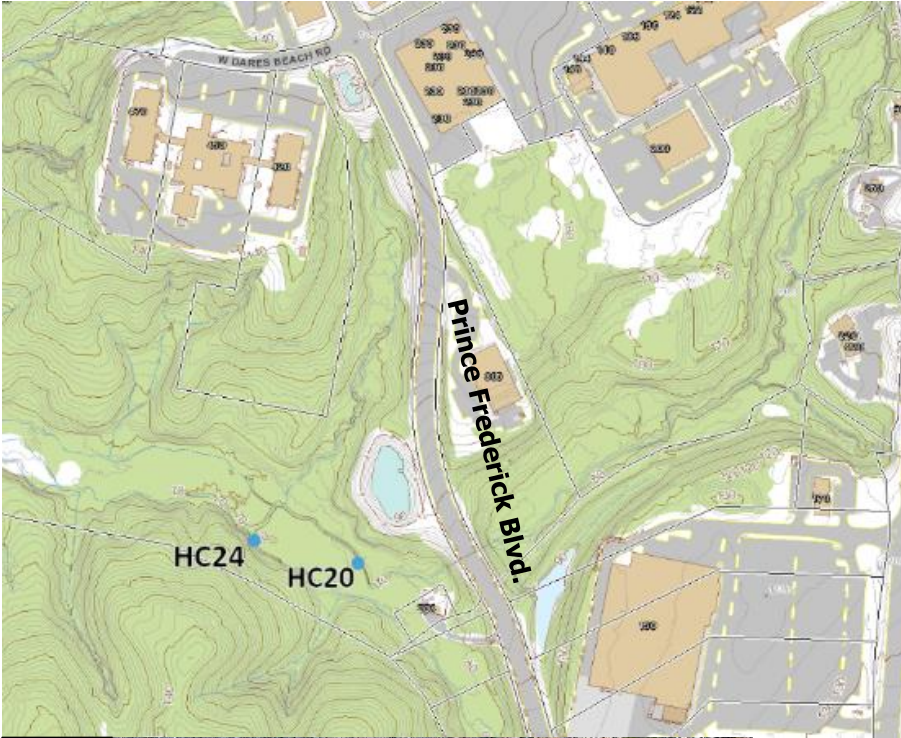
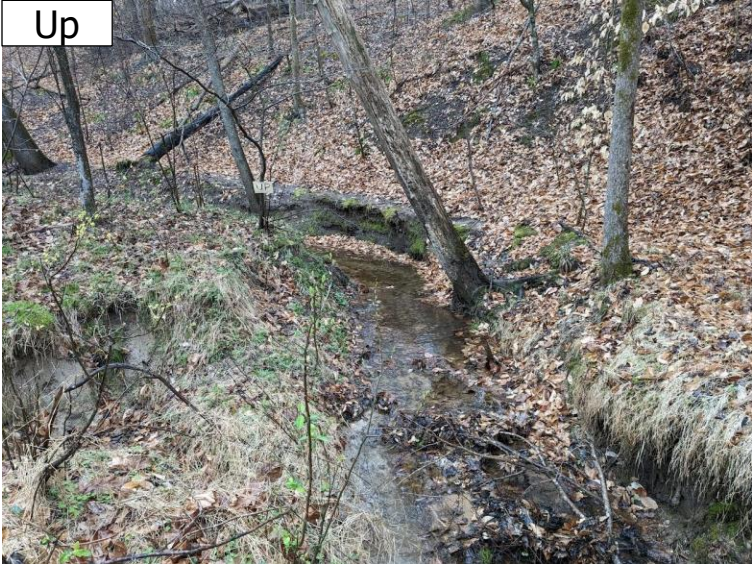
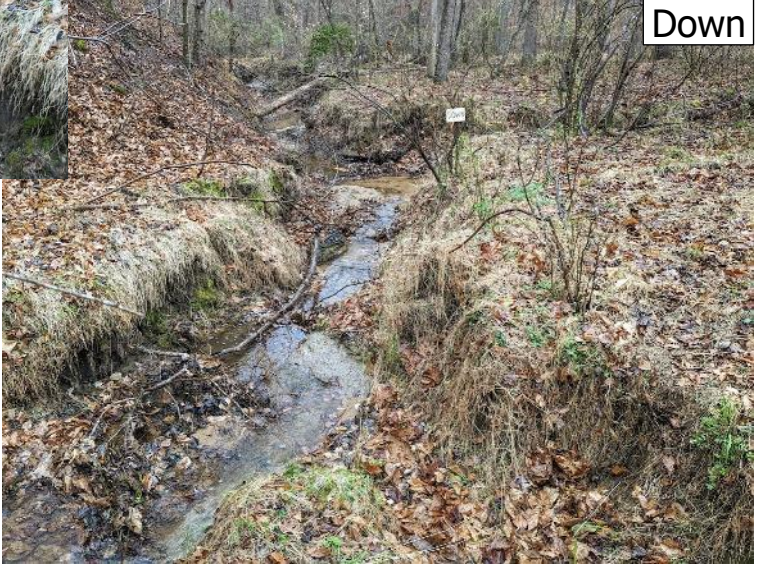
**HC24**

**Boulevard Branch, UT, 38.541467, -76.595070**

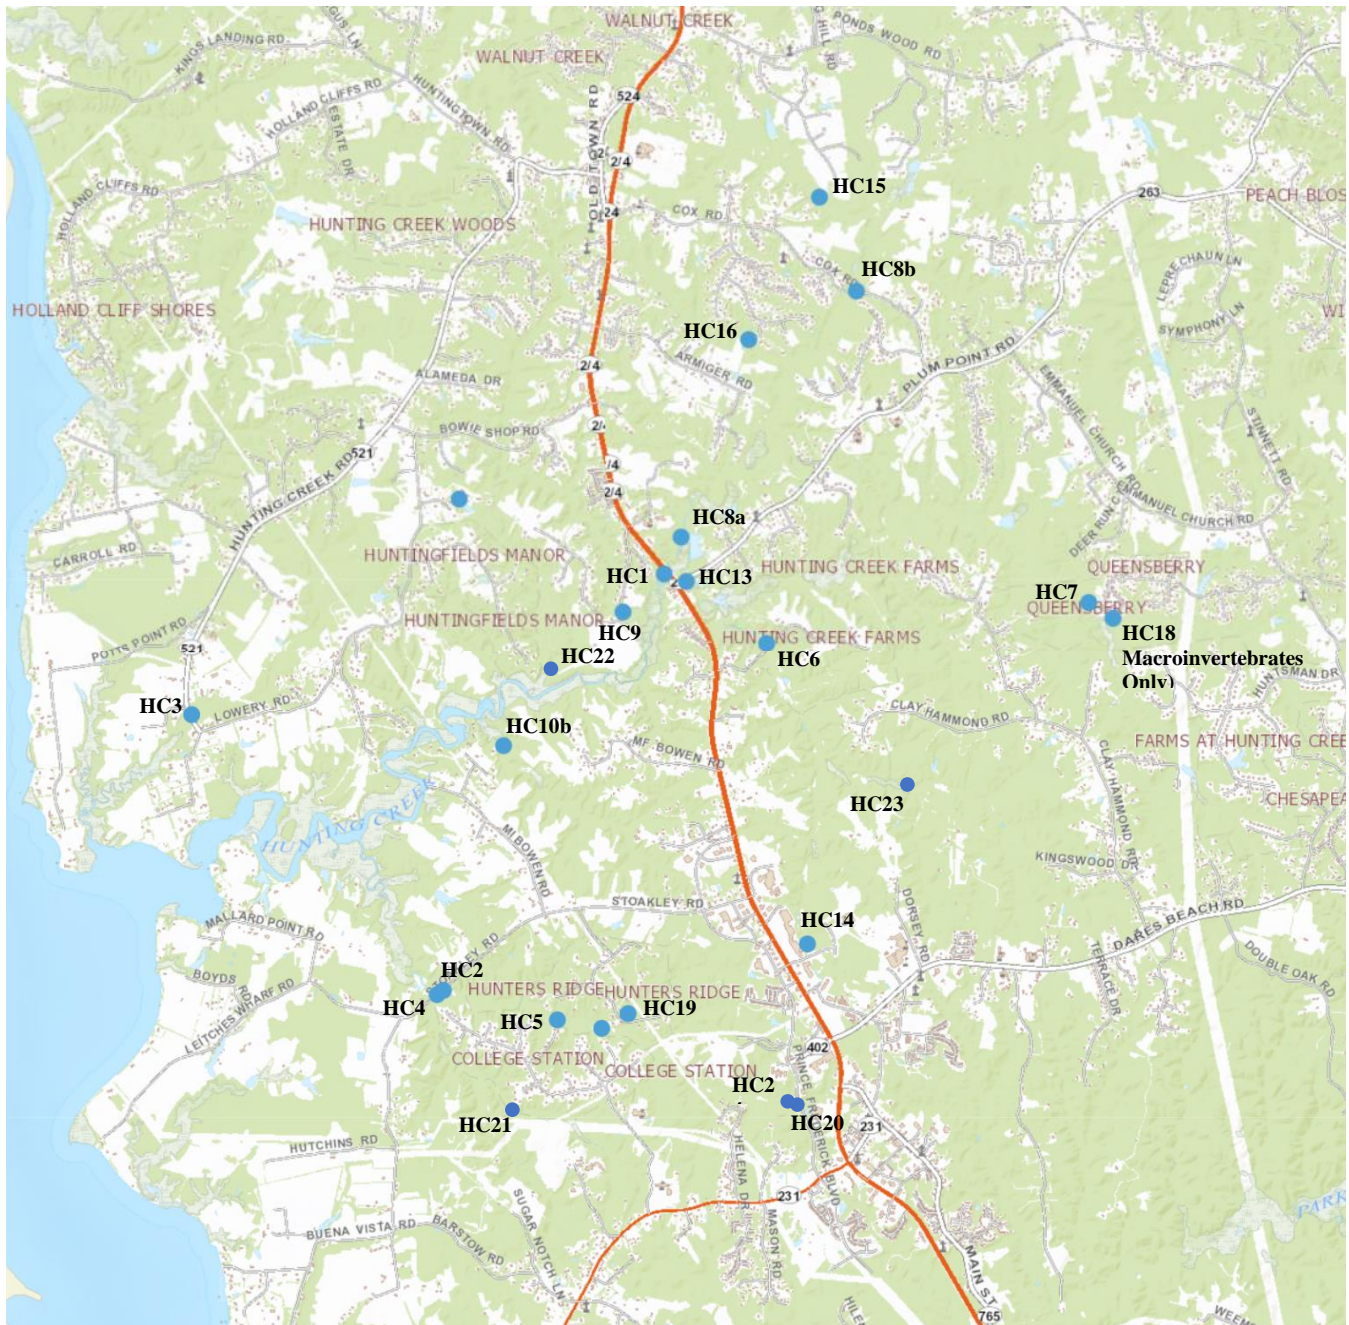
### **Figure F1. Locations of Sites Per Table A2-1 Coordinates**

The following Figure F1 and Table F1 are provided as orientation to the test sites from which samples were gathered during the 2023 Blitz and to provide background for some of the representative land cover data in the Hunting Creek watershed. Appendix A contains a map of the watershed and additional maps with higher resolution locations for each test site. (Note: This appendix will not appear in subsequent Blitz reports but will exist as a stand-alone document)

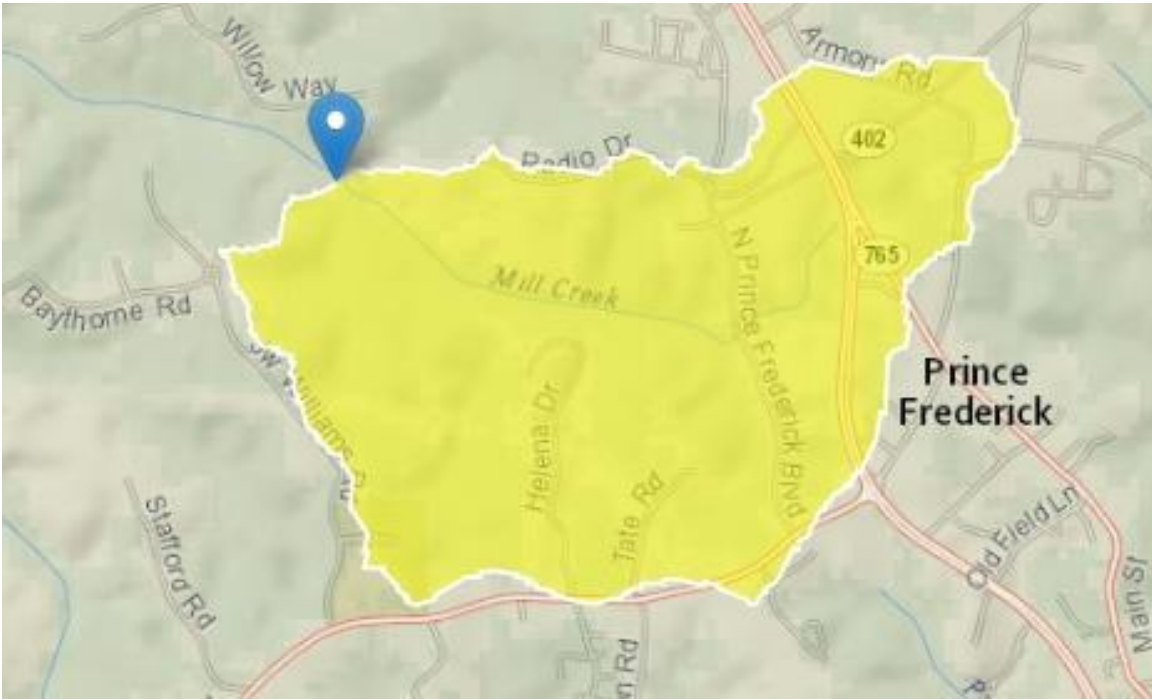
**Figure F18. HC13**

HC13	38.584250	-76.604804	Hunting Creek, Plum Pt. Rd.
------	-----------	------------	-----------------------------

Parameter Code	Parameter Description	Value	Unit
DRNAREA	Area that drains to a point on a stream	9.3	square miles
FOREST	Percentage of area covered by forest	69.9	percent

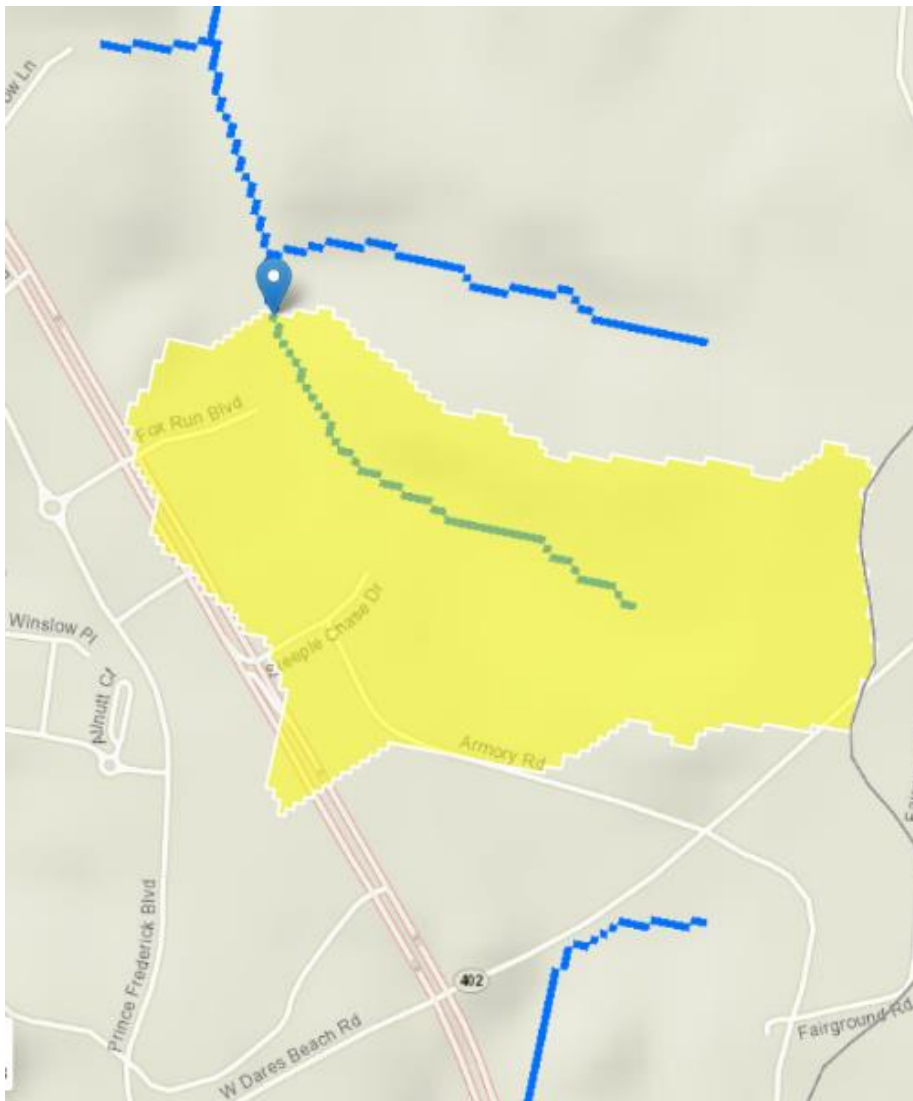
**Figure F20. HC15**

HC15	38.615396	-76.590811	Barberry Branch, Ponds Woods
------	-----------	------------	------------------------------

Parameter Code	Parameter Description	Value	Unit
DRNAREA	Area that drains to a point on a stream	1.04	square miles
FOREST	Percentage of area covered by forest	58.8	percent

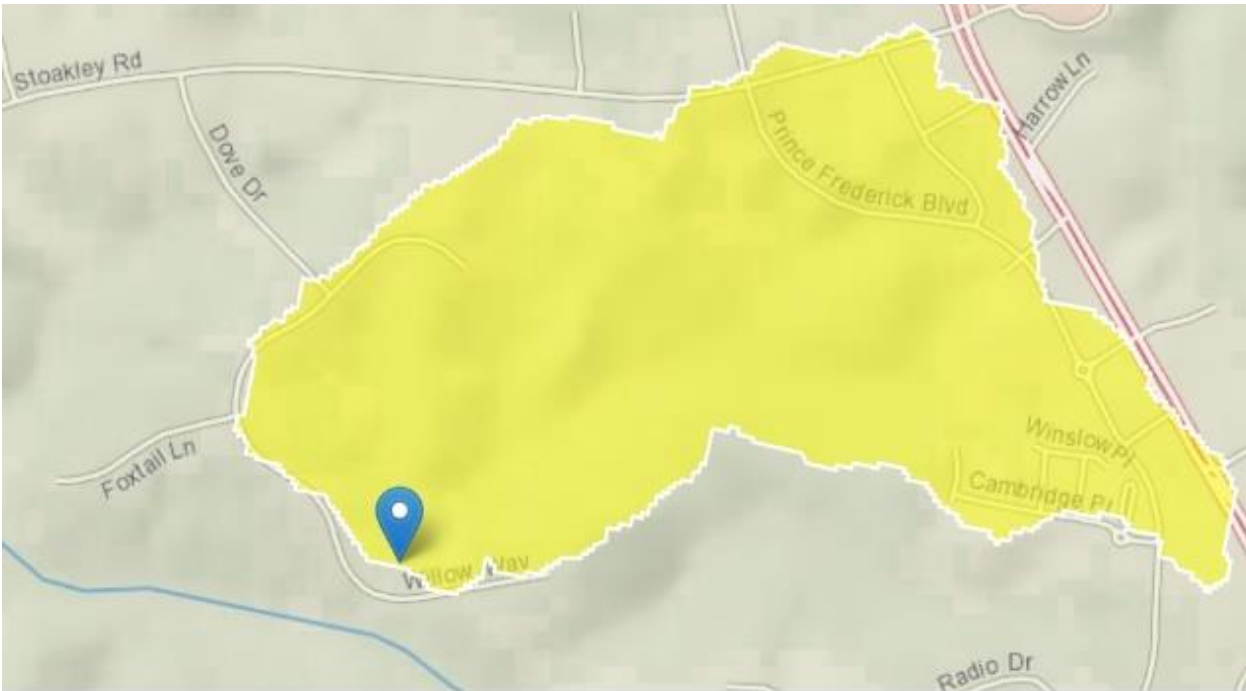
**Figure F24. HC20**

HC20	38.541126	-76.594114	upper Mill Creek, Prince Frederick Blvd
------	-----------	------------	---
